Manhole Inspection Summary

Manhole # S37MM_036MH

Insp Date: 1/31/07 11:08 AM

Location Address: **2120 GREENMOUNT AVE**

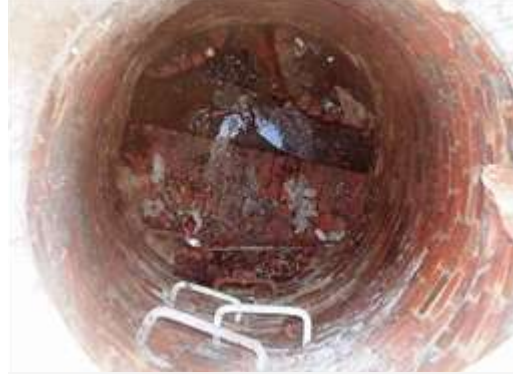
Top View

Channel debris. Evidence of surcharge - Bench debris. Channel debris.

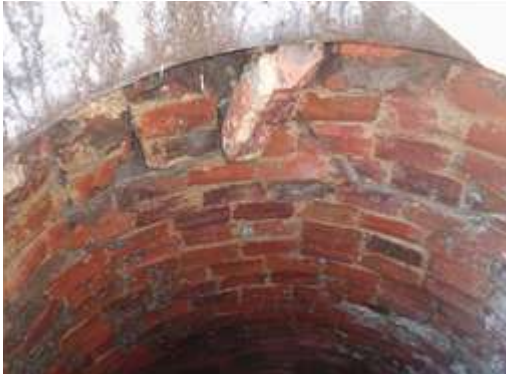
Defect

Frame leaks. Adjustment deterioration, loose brick and infiltration. Corbel and Barrel infiltration.

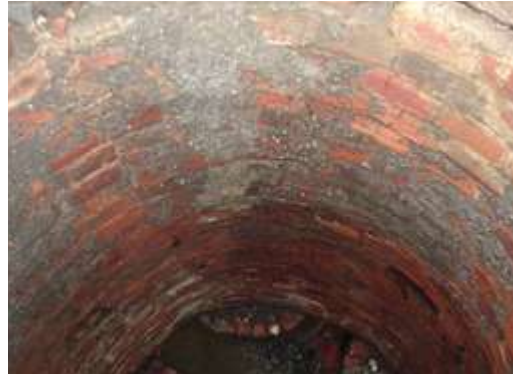
Defect

Adjustment, Corbel and Barrel infiltration.

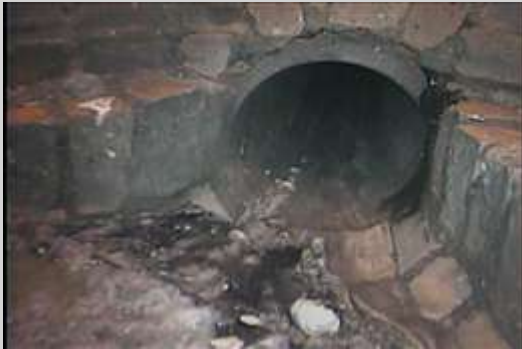
8 in. Circular Gravity Sewer Pipe Out @ 12 O'Clock

Infiltration: **Evidence** Pipe Seal Cond: **Cracked**

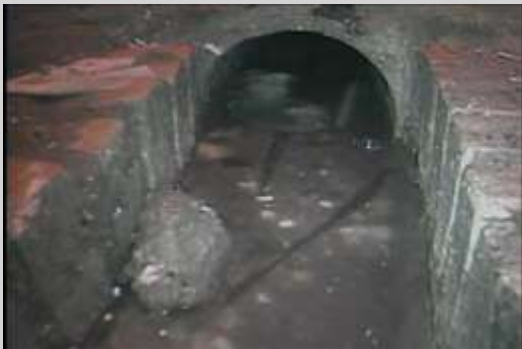
8 in. Circular Gravity Sewer Pipe In @ 3 O'Clock

Deposits: ☐ None ☒ **Mud** ☐ Sludge ☒ **Debris** ☐ Grease

Silt Depth: **1** (in.) Deposits Extent: **Light**

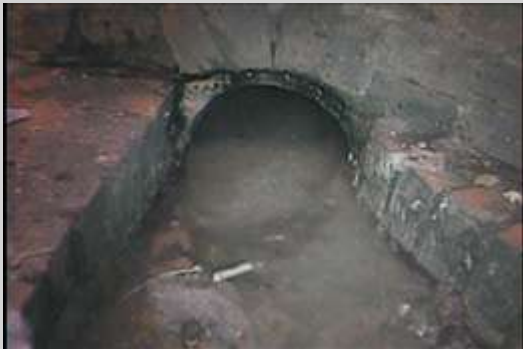
8 in. Circular Gravity Sewer
Pipe In @ 9 O'Clock

Deposits: ☐ None ☒ **Mud** ☐ Sludge ☒ **Debris** ☐ Grease

Silt Depth: **3** (in.) Deposits Extent: **Medium**

Infiltration: **Evidence** Pipe Seal Cond: **Unknown**
